## **Fort Leonard Wood Lake of the Ozarks Recreation Area, NRHP Section 110 Inventory and Evaluation**

Sunny E. Adams and Adam D. Smith

June 2016

Final report

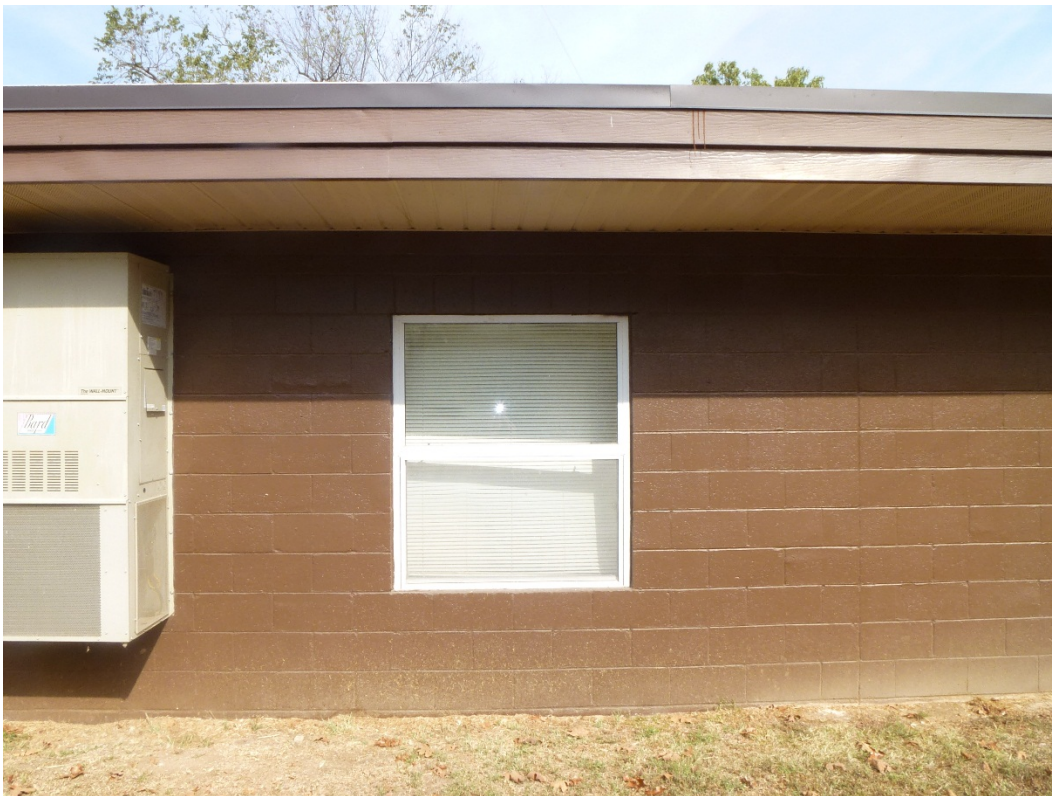
Figure 73. Close-up of a replacement vinyl one-over-one window on the south elevation of Building 560 (ERDC-CERL, 2015).

Building 560 is a one-story structure with a rectangular footprint and a flat built-up roof with overhanging eaves. The overhanging eaves have been modified with newer metal fascia and metal soffits covering the original exposed rafter system (Figure 72). The exterior walls are constructed of concrete block. All of the windows on the building are replacement vinyl windows. The types of windows are one-over-one double-hung and two-pane slider windows (Figure 73 and Figure 74). The middle section of the south elevation consists of three metal doors and two smaller narrow slider windows. There is a single-entry door on the left side of the south elevation (Figure 75). There are two replacement one-over-one windows and a door on the right side of the south elevation. The west elevation is two-part: the left side projects outward and there is a single entry door on this part of the wall, and the right side of the elevation is recessed (Figure 76). The windowsills are concrete block. The doors are metal and are all replacement.

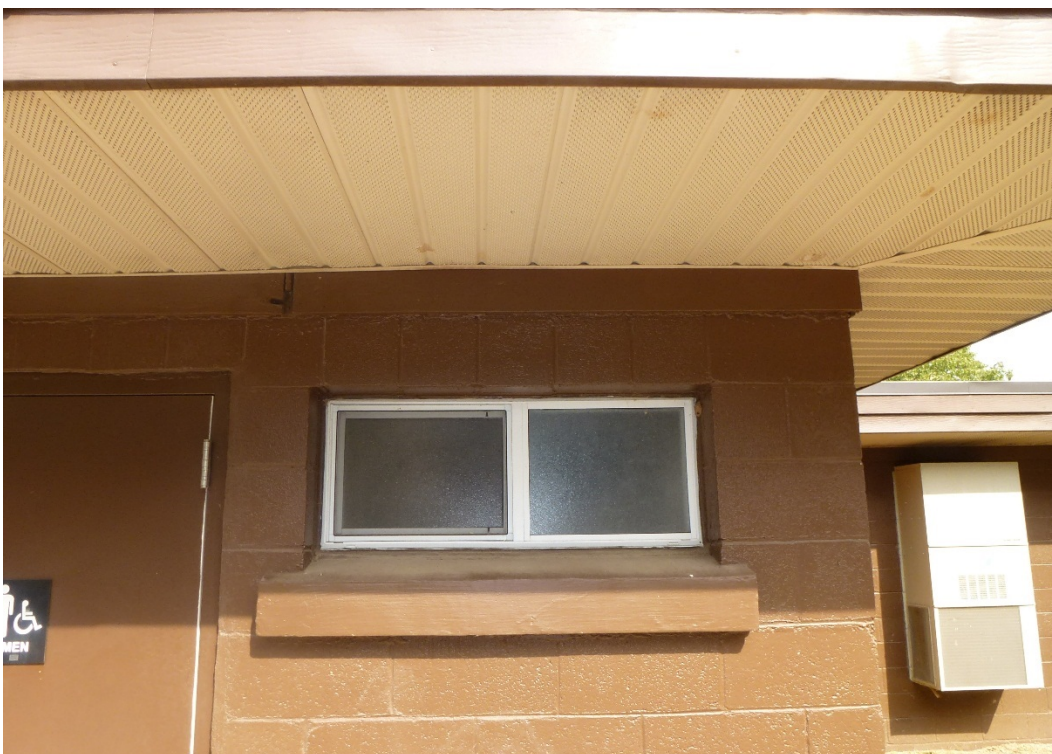
Figure 75. Left side of the south elevation of Building 560 (ERDC-CERL, 2015).

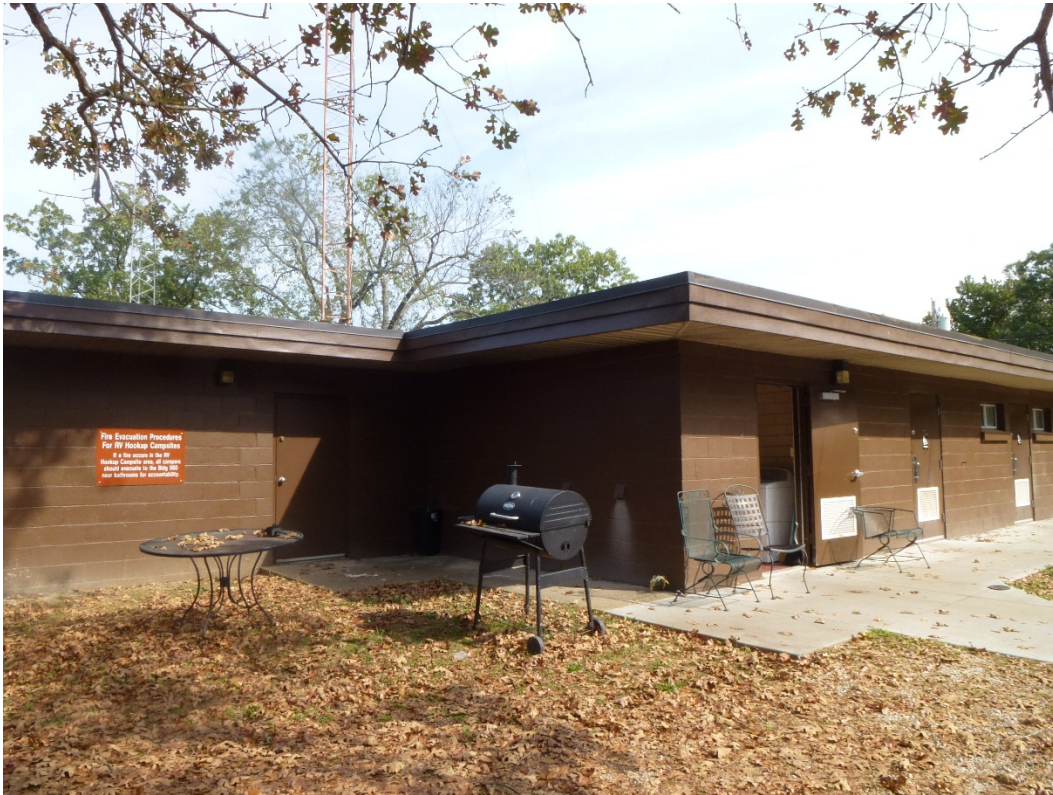
Figure 76. West elevation of Building 560 (ERDC-CERL, 2015).

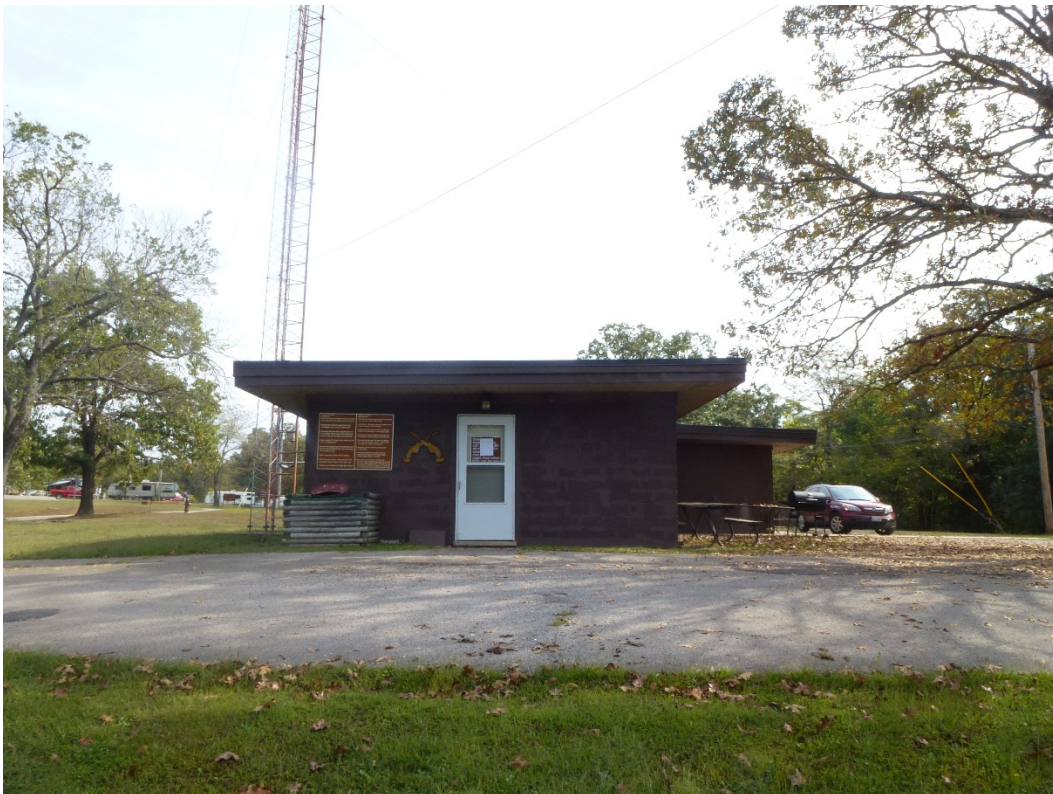
Figure 77. Interior view of the laundry facility of Building 560 (ERDC-CERL, 2015).

Building 560 serves two functions: the north part of the building is administrative space, while the south portion of the building is a laundry/bath house. The interior of the laundry/bath house has original glazed sanitary tile walls (Figure 77).

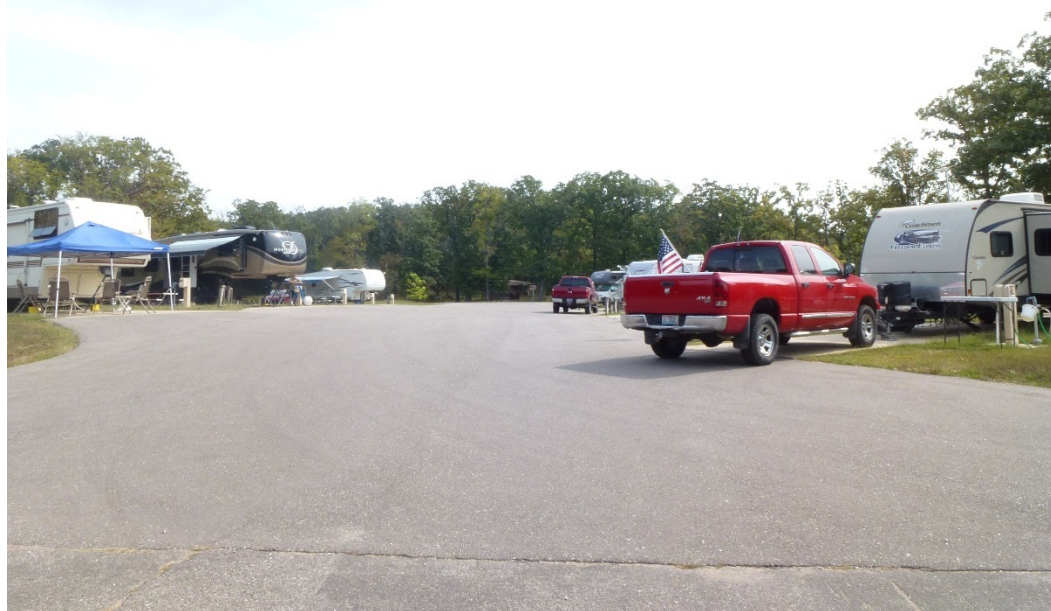
Figure 86. Looking east at the pull-through RV hook-up area (ERDC-CERL, 2015).

There is a pull-through RV hook-up area just northeast of the Military Police (MP) station at the intersection of Olney Circle and Pippen Drive (Figure 85). This area includes 11 concrete pads for RV parking (Figure 86 and Figure 87). There are also 16 back-in RV hook-up sites that are nestled in a wooded area south of Olney Circle. This area is a bit more secluded than the pull-through site.

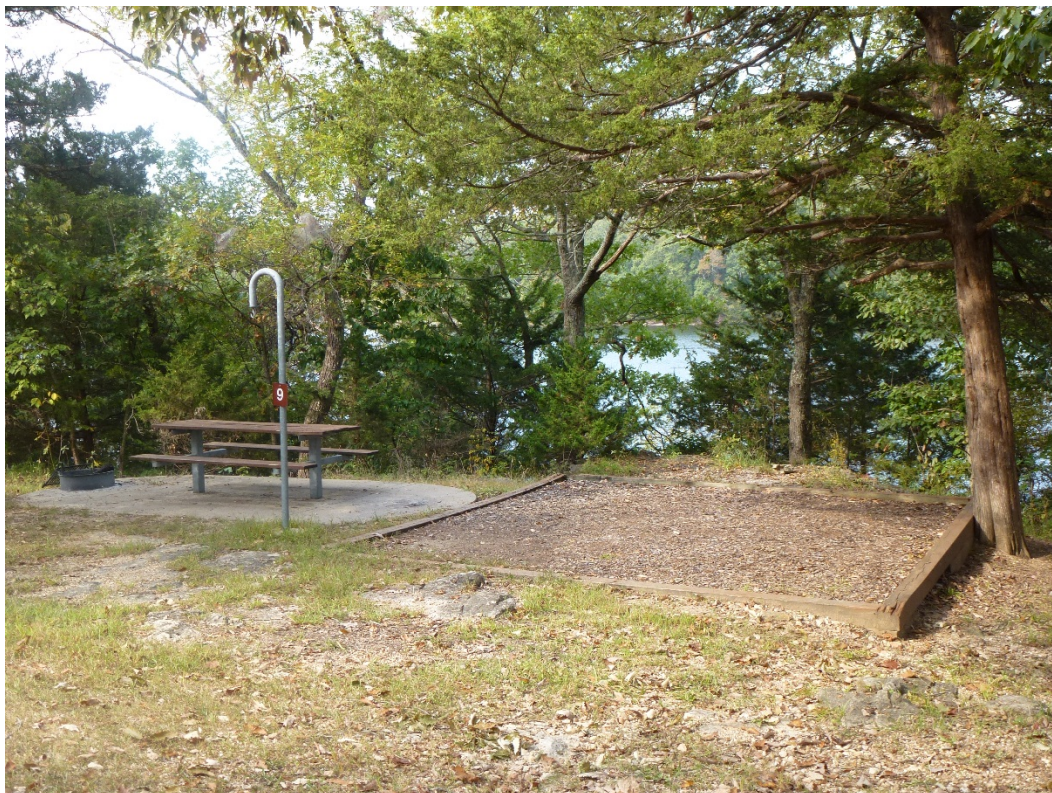
Figure 89. Example of a rustic campsite (ERDC-CERL, 2015).

There are 22 rustic campsites located on the south side of the site, located off Olney Circle (Figure 88). These sites are simple in nature and include a small earthen pad for a tent, a concrete pad with picnic table, and a fire pit (Figure 89).

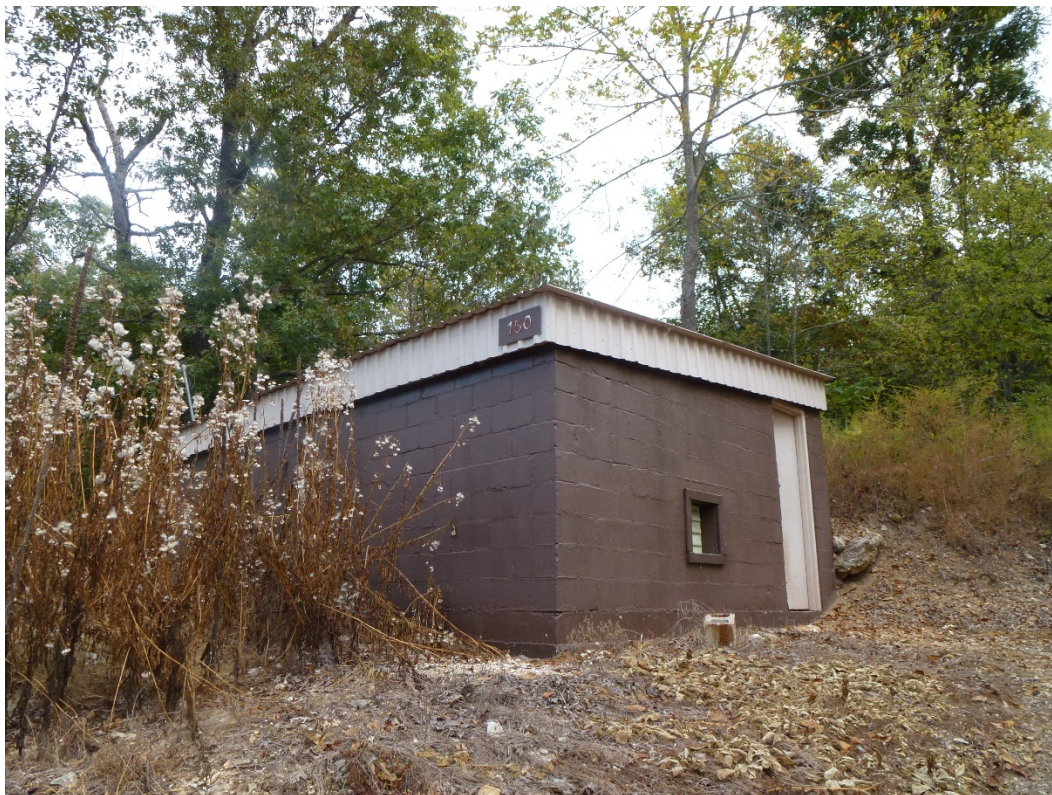
Figure 90. Southwest oblique of Building 150 (ERDC-CERL, 2015).

Building 150 is a small, simple, rectangular structure with concrete block exterior walls. The building has a metal shed roof with a metal fascia system. There is a single metal entry door and a small louvered vent on the south elevation (Figure 90). There are no door or window openings on the north, east, or west elevations.

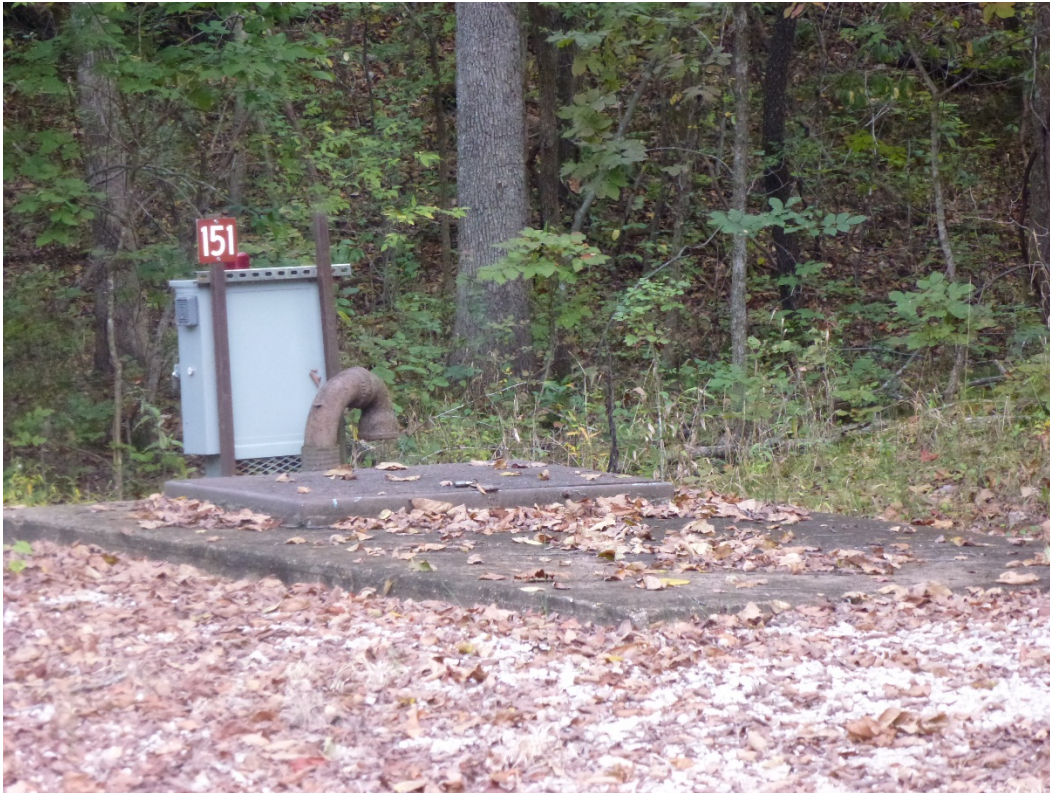
Figure 91. View toward Building 151 (ERDC-CERL, 2015).

146 are located to the west across Lake Road, and Building 150 is located to the north. The building is set into a hill and surrounded by vegetation. Building 151 is a concrete chamber below grade (Figure 91).

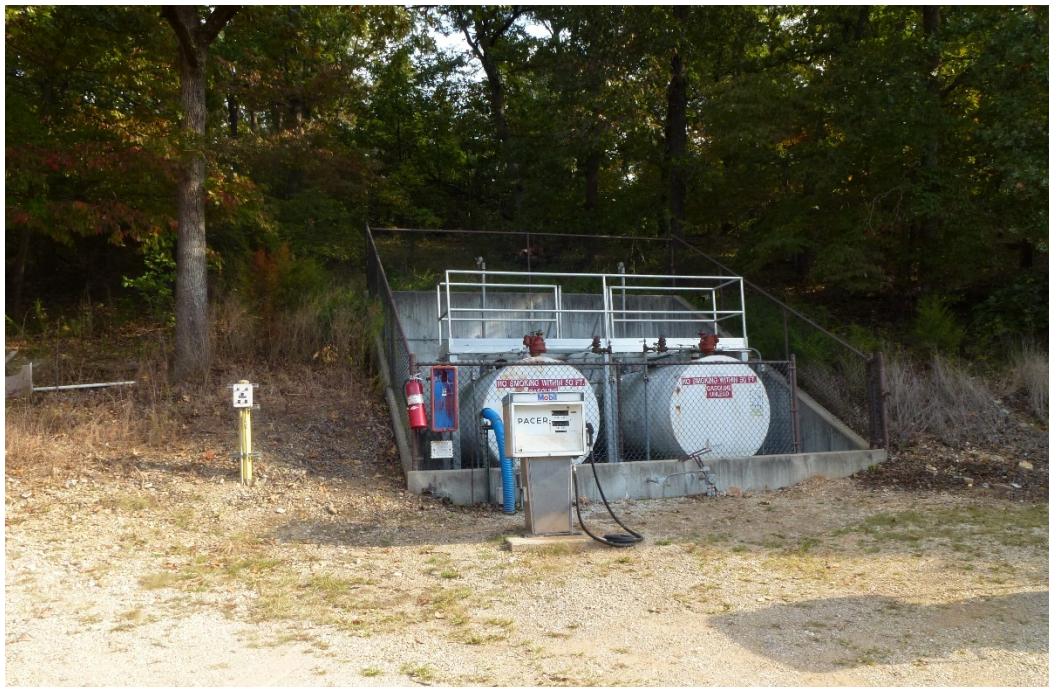
Figure 92. Building 538 with fuel-pumping station in foreground (ERDC-CERL, 2015).

Building 538, vehicle fuel mobility gasoline (MOGAS), was constructed in 1961 as a fuel station for vehicles. The building is located on the west side of LORA, and it overlooks the lakeshore and marina. Olney Circle is located on the south side of the utility, while a sloping, tree-covered hill frames the north side of the building. Building 506 is located to the west. The structure of this utility is comprised of a concrete pad with concrete retaining walls that house two above-ground fuel tanks. A fuel pumping station is located nearby (Figure 92).

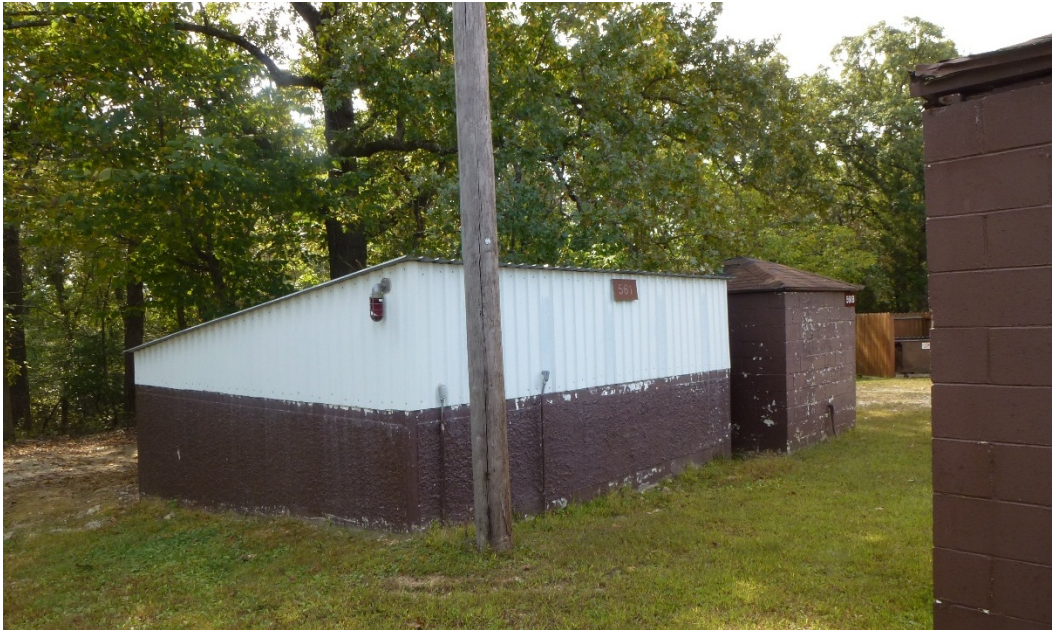
Figure 93. North oblique of Building 561 (ERDC-CERL, 2015).

Building 561 is a one-story structure with a T-shaped footprint. The building's exterior walls are constructed of concrete, with a textured stucco finish on the bottom half and metal siding on the top half. The building has a metal-clad shed roof. There are no door or window openings on the northeast, northwest, or southwest elevations (Figure 93 and Figure 95). A concrete/stucco appendage projects off the southeast side of the building. This part of the structure is covered with a shallow barrel concrete roof (Figure 94). There is a single-entry metal door located on this elevation. Shallow poured-concrete walls and a poured-concrete pad frame the entry to this door.

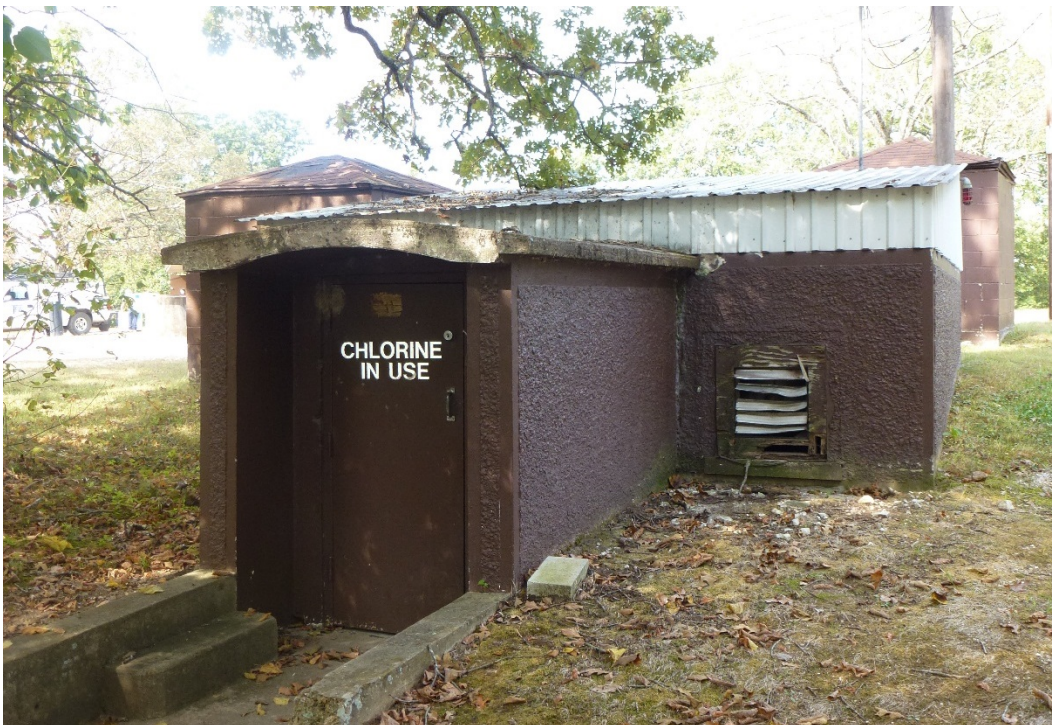
Figure 94. Southeast elevation, showing the concrete appendage of Building 561 (ERDC-CERL, 2015).

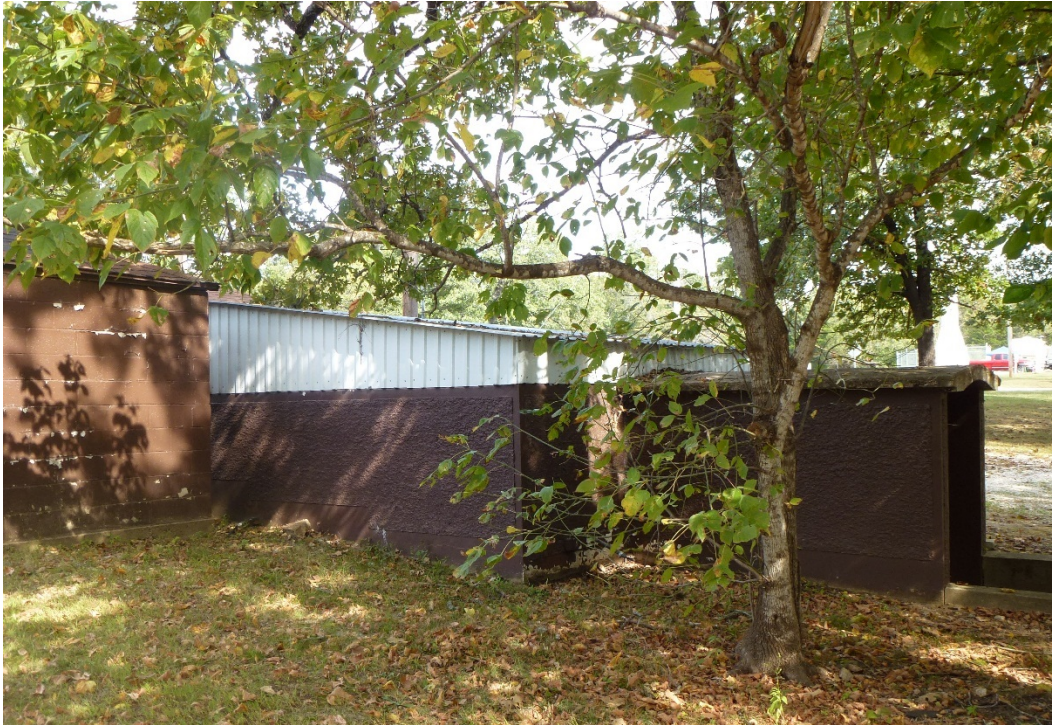
Figure 95. Southwest elevation of Building 561 (ERDC-CERL, 2015).

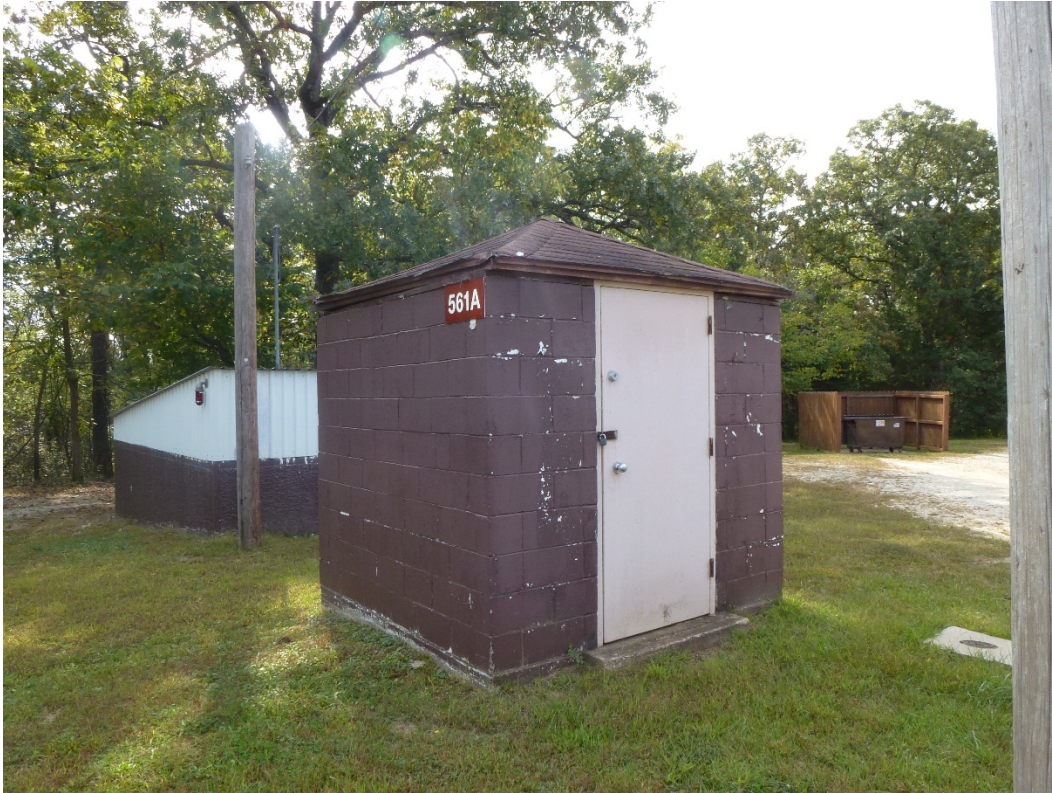
Figure 96. Northeast oblique of Building 561A (ERDC-CERL, 2015).

Buildings 561A and 561B are simple one-story concrete block structures with a square footprint (Figure 96 and Figure 97). Each structure has a hipped roof that is clad with asphalt shingles. Each building has a concrete slab foundation. Each structure has one single-entry door. There are no window openings on either structure.

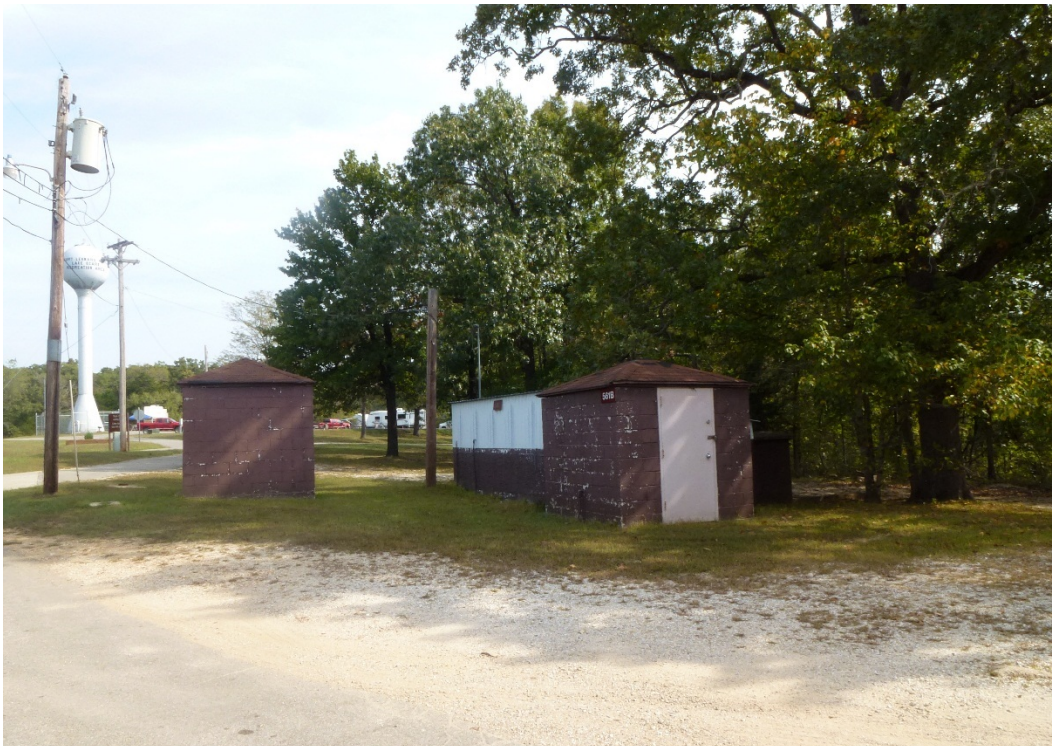
Figure 97. Southwest oblique of Building 561B [right] and south elevation of Building 561A [left] (ERDC-CERL, 2015).

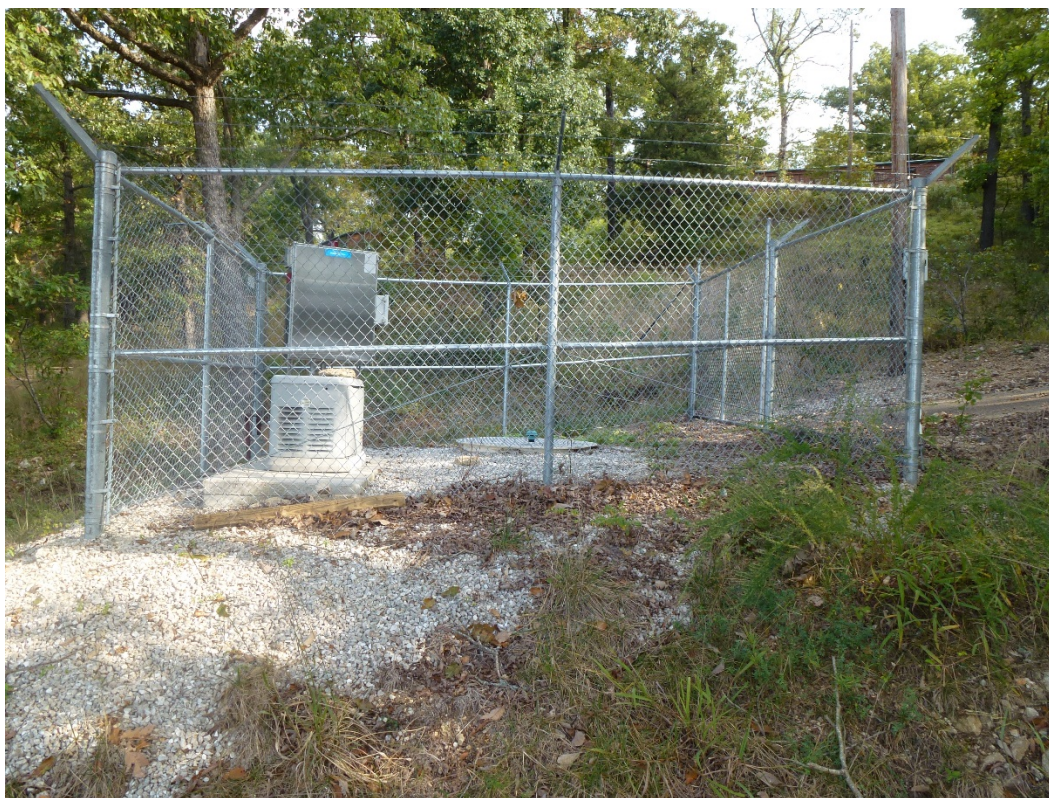
Figure 98. View of Building 610 (ERDC-CERL, 2015).

Building 610, sewage lift station, was constructed in 1961 as a support facility for LORA. The utility is located on the west side of LORA. Building 610 is located near Buildings 550 and 555. It appears that the original concrete chamber that was constructed in 1961 has been removed, and a newer type of sewage lift station has been built underground and then secured by a chain-link fence (Figure 98). At the time of the site visit, there was no building number associated with this newer facility.

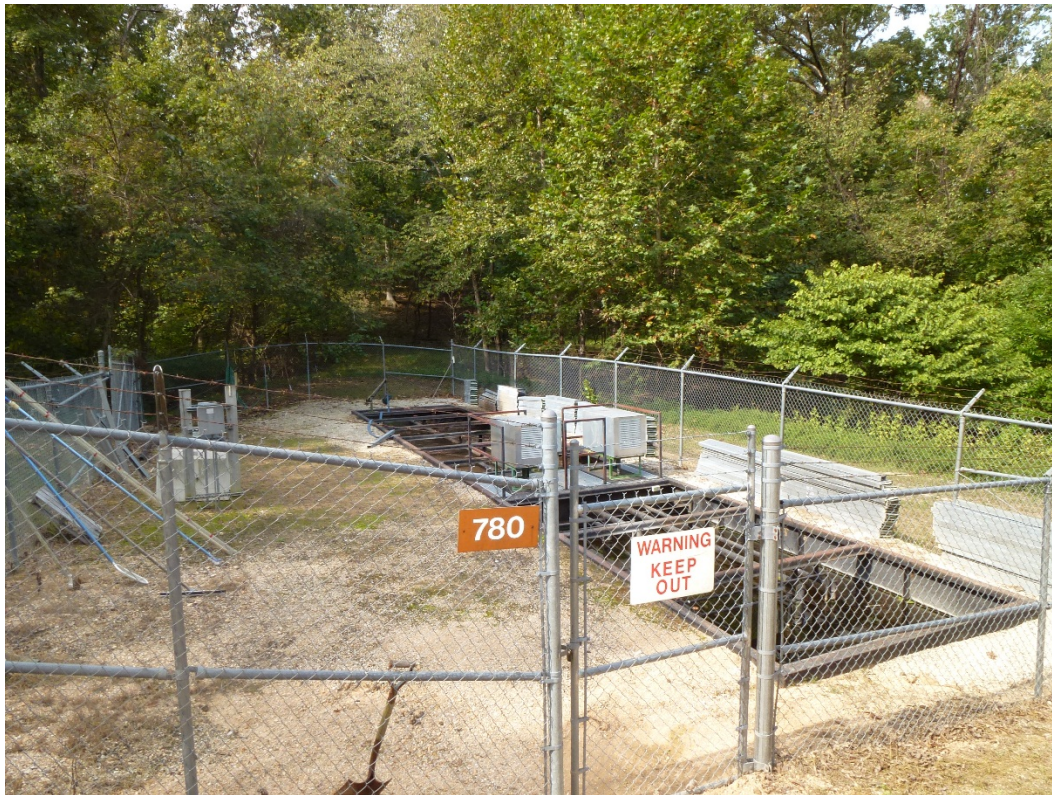
Figure 99. Looking at Building 780 (ERDC-CERL, 2015).

Building 780, industrial waste treatment, was constructed in 1961. It was constructed as a support facility for LORA. The facility is located on the far northwest corner of the LORA site. The building is accessible by a dirt road that branches off Pippen Drive. The facility is a long rectangular “pool.” The whole facility is surrounded by a chain-link fence (Figure 99).

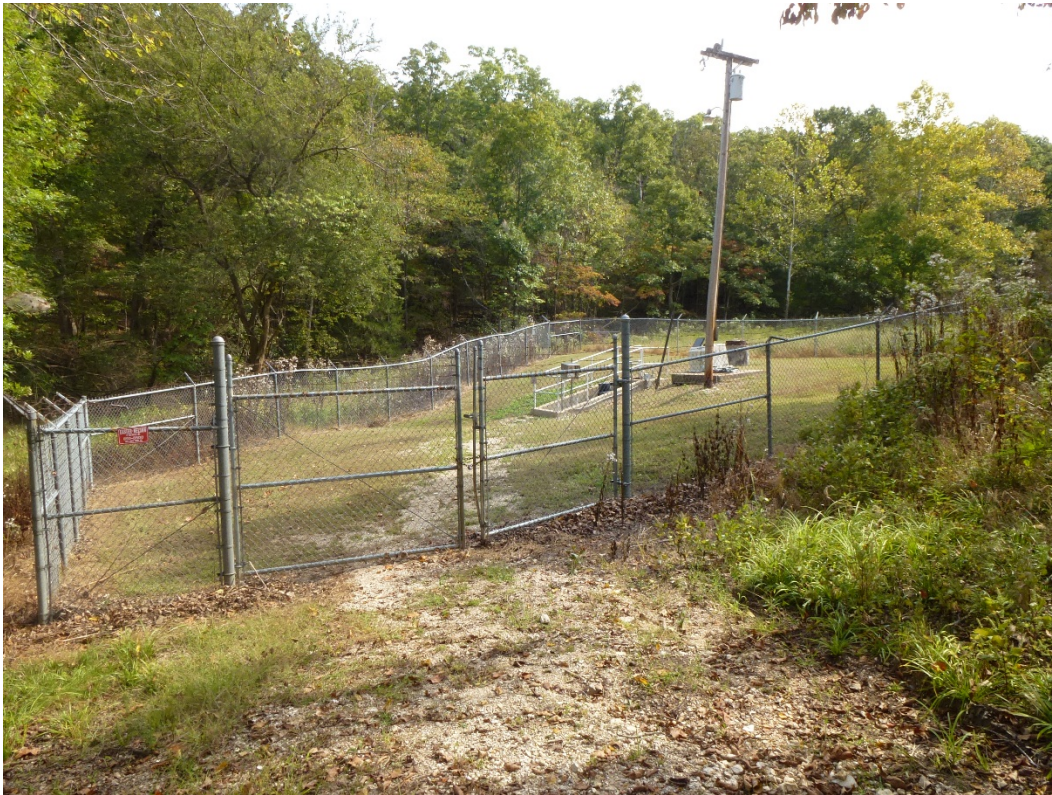
Figure 100. Site of Building 781 (ERDC-CERL, 2015).

Building 781, IND (industrial) waste treatment, was constructed in 1961. The facility was built as a support facility to serve LORA. It is located at the northwest edge of the LORA site and is accessible down a dirt road from Building 780. The facility is constructed of poured concrete and is located mostly underground. A security fence surrounds the facility (Figure 100).

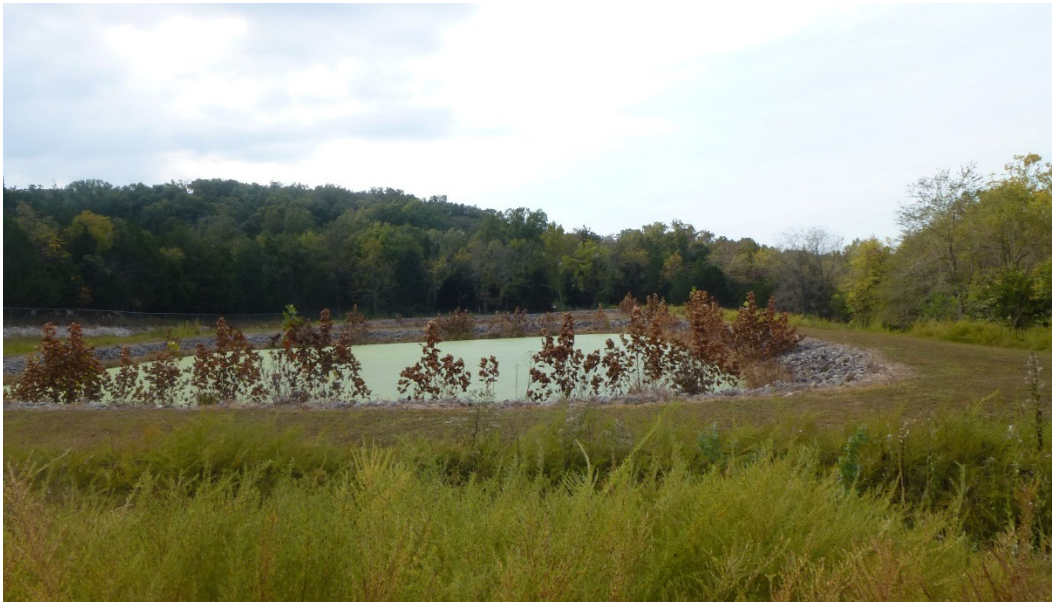
Figure 101. Looking at one of the two waste lagoons located at the south end of LORA (ERDC-CERL, 2015).

Two large wastewater lagoons are located at the far southwest end of the LORA site. These lagoons are surrounded by grasslands and protected by a security fence (Figure 101). It is unclear what dates these lagoons were created at LORA. There are also two other large lagoons located at the north end of LORA. These lagoons were not accessible to the researchers. The area was surrounded by chain-link fencing (Figure 102). According to a 1967 map, these were sewage lagoons.

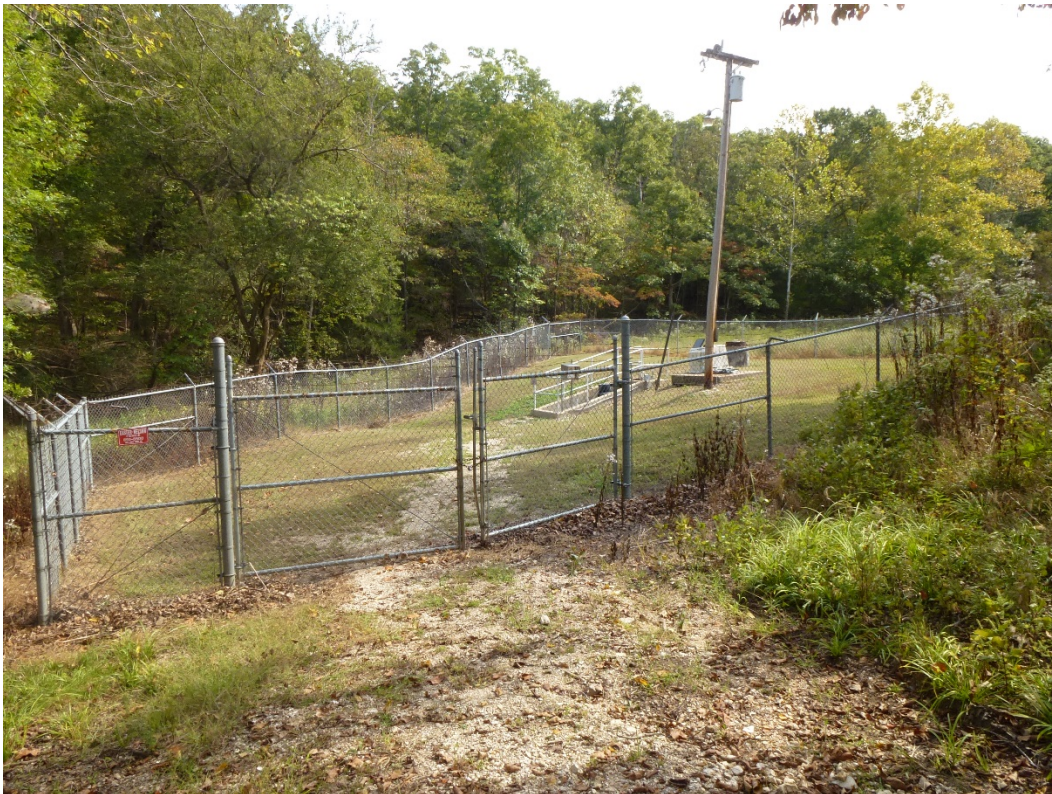
Figure 102. View of fenced area surrounding the lagoons on the north end of LORA (ERDC-CERL, 2015).<sup>4</sup>

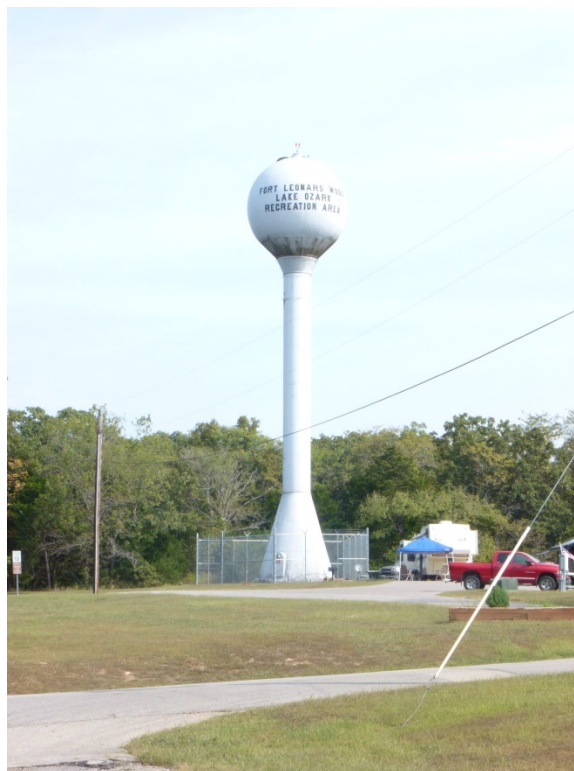
Figure 103. LORA water tower (ERDC-CERL, 2015).

A main water tower is located near the center of the LORA site. It is adjacent to the back-in RV hook-up sites, and it is north of Building 560 that houses the administrative office/laundry. The water tower has a large sphere at the top of its post with the lettering “Fort Leonard Wood Lake Ozark Recreation Area” painted on it (Figure 103). A security fence surrounds the base of the tower.

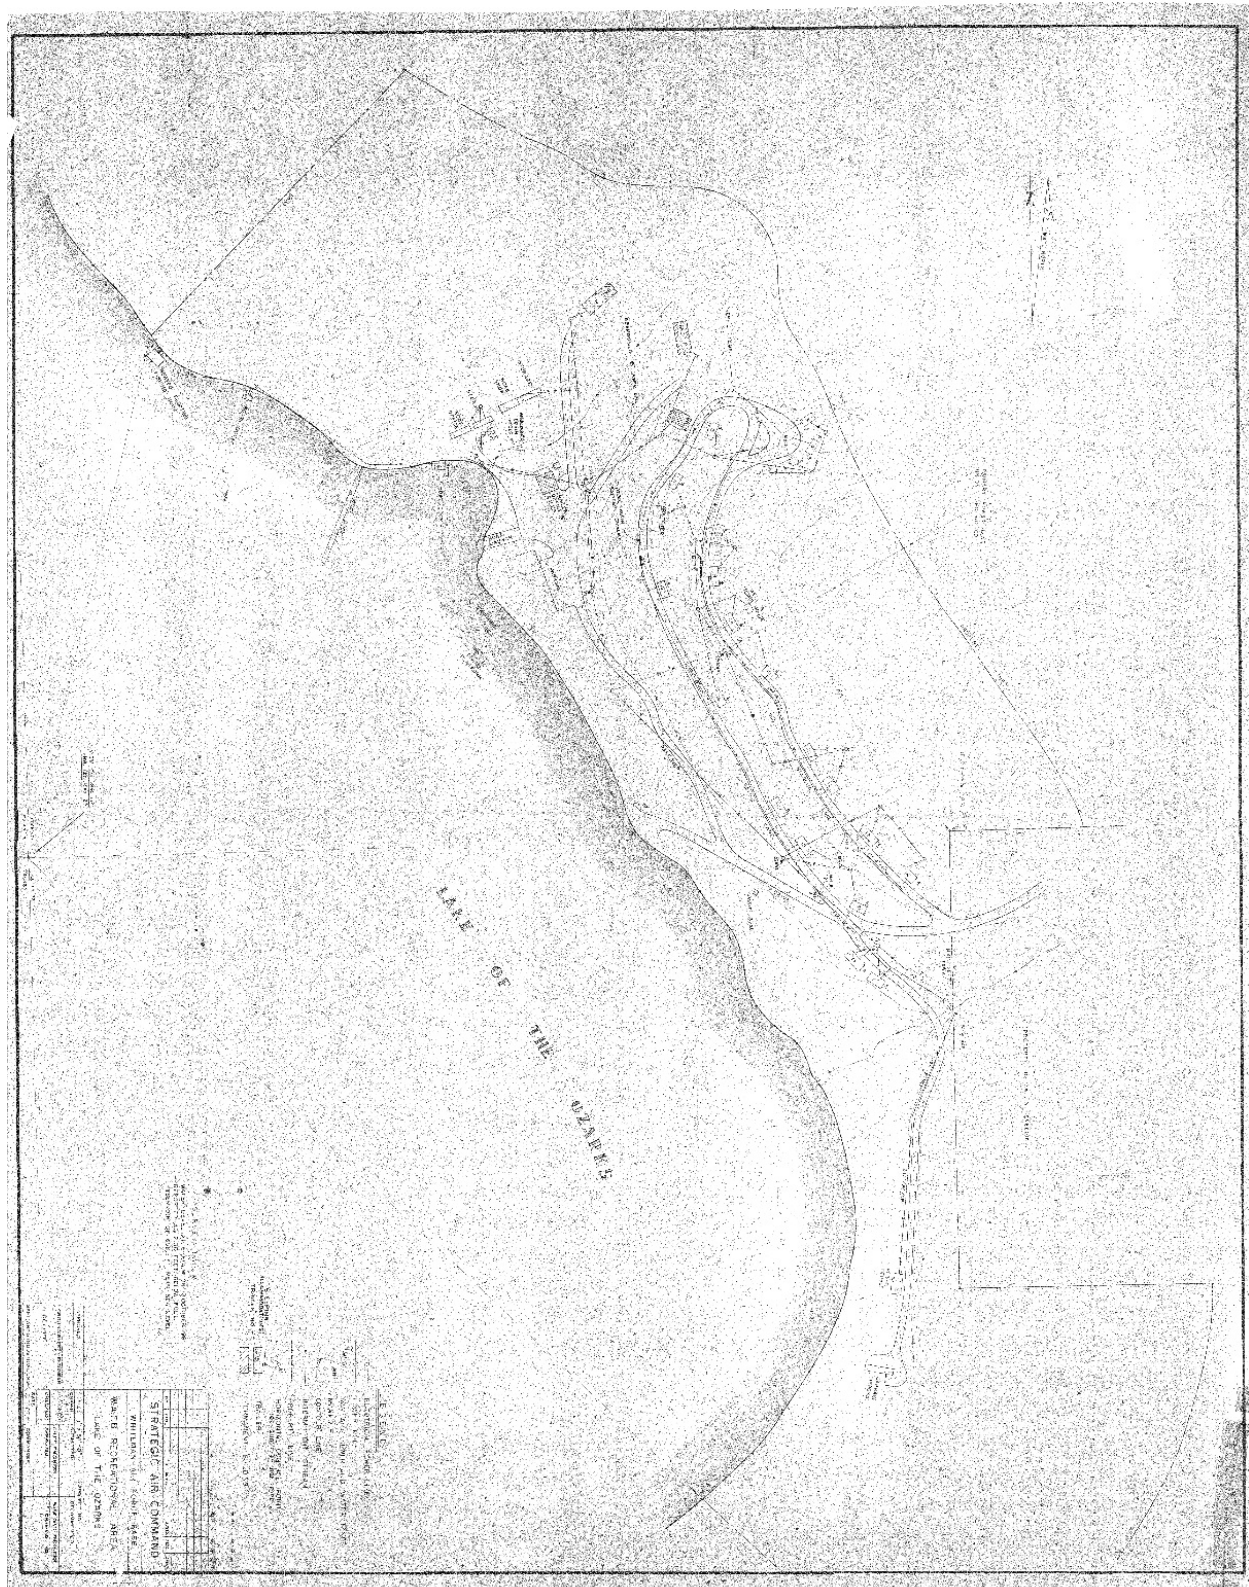
**Figure 105. Site and utilities map of the south recreation area, 1961 (DPW, FLW).**

The majority of the LORA site is covered by vegetation, with minimal man-made circulation whether it be vehicular or pedestrian. A 1961 map of the south recreation area (Figure 105) and an overall 1967 map of LORA (Figure 106) show early circulation patterns of roads and some sidewalks. The majority of the original circulation patterns and layout of the roads and sidewalks are still intact.

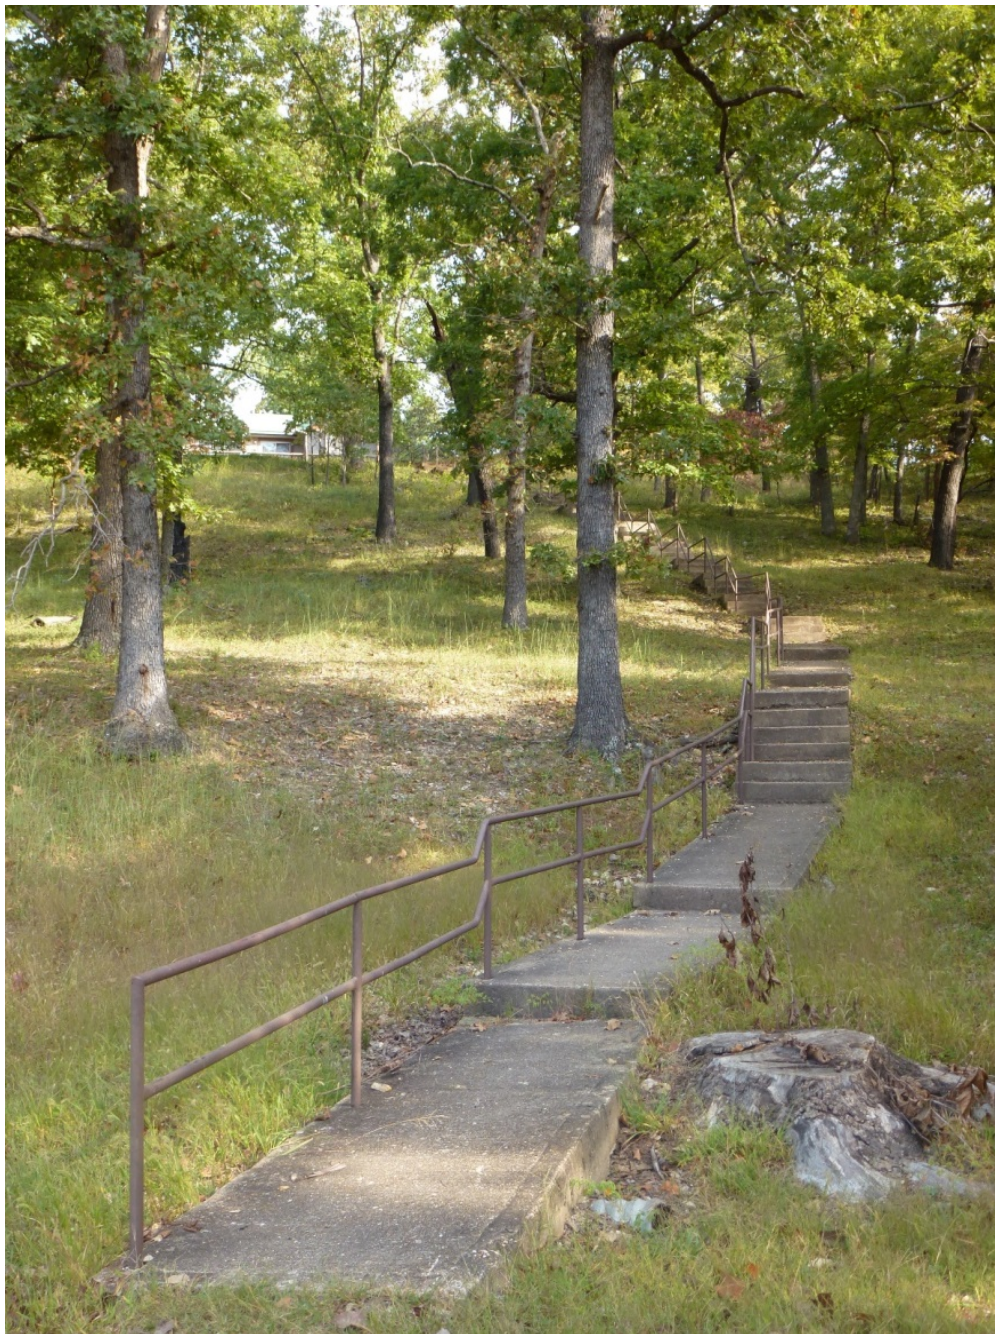
Figure 111. Original sidewalk and steps leading from Building 500 (general store) up the hillside to the back-in style RV hook-up sites (ERDC-CERL, 2015).

The LORA site sits up on a bluff overlooking the lake. A number of poured concrete sets of steps with metal pipe handrails were constructed in the early years of LORA, circa 1961, in order to help provide access for the guests from the “trailer sites” [now cabins] down to the lakeshore, recreation shelter, swimming area, and marina. Several of these long sidewalk/steps are still intact (Figure 111 and Figure 112). There have been a few newer sidewalks added at later dates to help with the circulation pattern and ease of getting around LORA (Figure 113 through Figure 115).

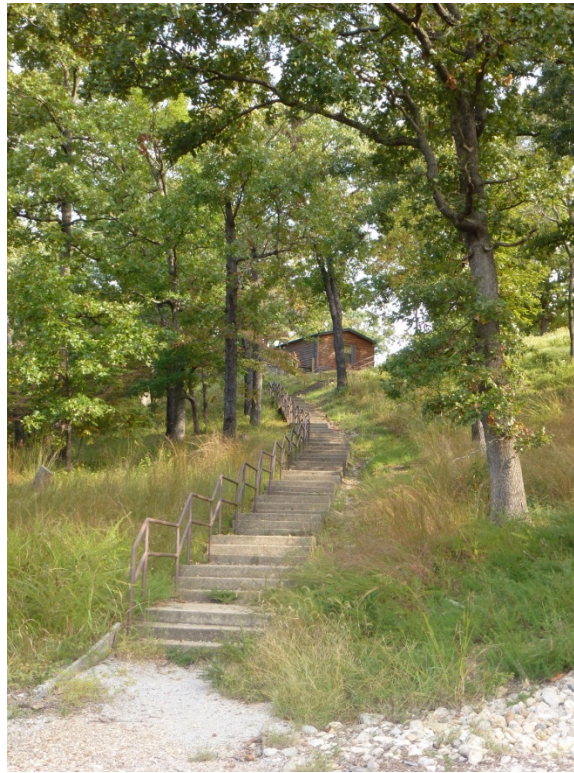
Figure 112. Original concrete sidewalk and steps leading from the swimming area up the hillside to the rental cabins along Phippen Drive (ERDC-CERL, 2015).

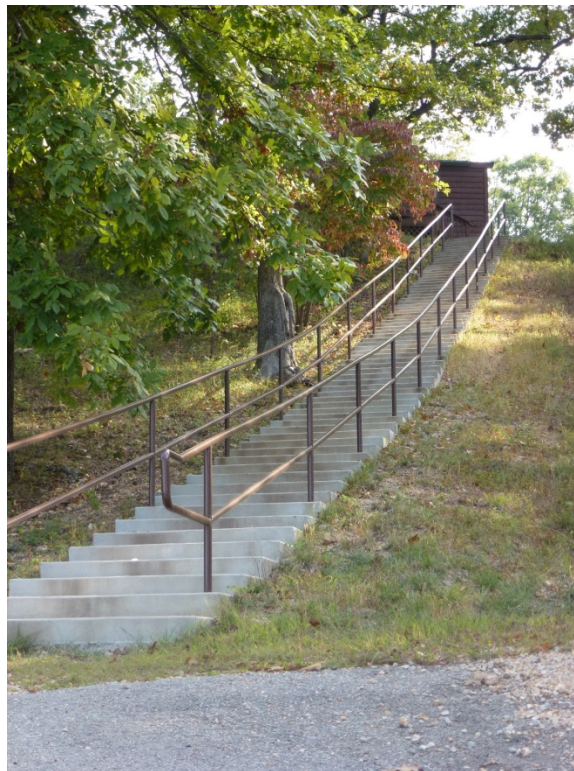
Figure 113. A set of newer concrete steps leading up the hillside to a cabin off Phippen Drive (ERDC-CERL, 2015).
